Furnace Will Not Start (...sometimes...)

Problem: My Atwood furnace will, on occasion, not start or having started, will just randomly turn off (usually in the middle of a cold night). Nothing works, not even the fan. Everything else in the trailer works fine.

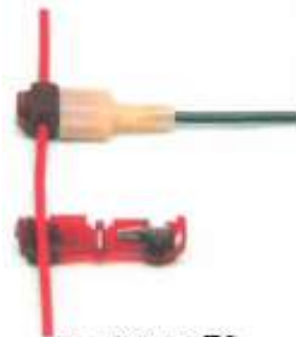
Figure (1) IDC Connectors

These connectors are designed to splice connections into other wires without the need for cutting and soldering. They come in all sorts of sizes and for all types of uses and are used extensively in our RV's. The color of the connector indicates the wire gauge size it is designed for. A quick check is to see if it will move on the wire it is spliced too, which would indicate a poor connection. If it moves at all, do not try to re-clamp the connection, move to an adjacent area on the wire and just replace it with the proper size connector.
