Dexter Nev-R-Lube™ Axle

Airstream started using Dexter Nev-R-Lube axles with disc brakes on Classic Airstream trailers starting in July of 2005.

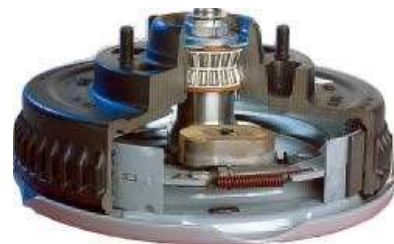
Nev-R-Lube™ bearings consist of opposed tapered roller bearing cones sealed inside of a one piece double cup arrangement. These bearings are designed with a small amount of end play; this end play is essential to the longevity of the bearing's service life. *This cartridge only has to be removed if there is a problem with the cartridge, the hub can be removed without disturbing the cartridge.*
