Main Door Hinge Pin with “C” Clip

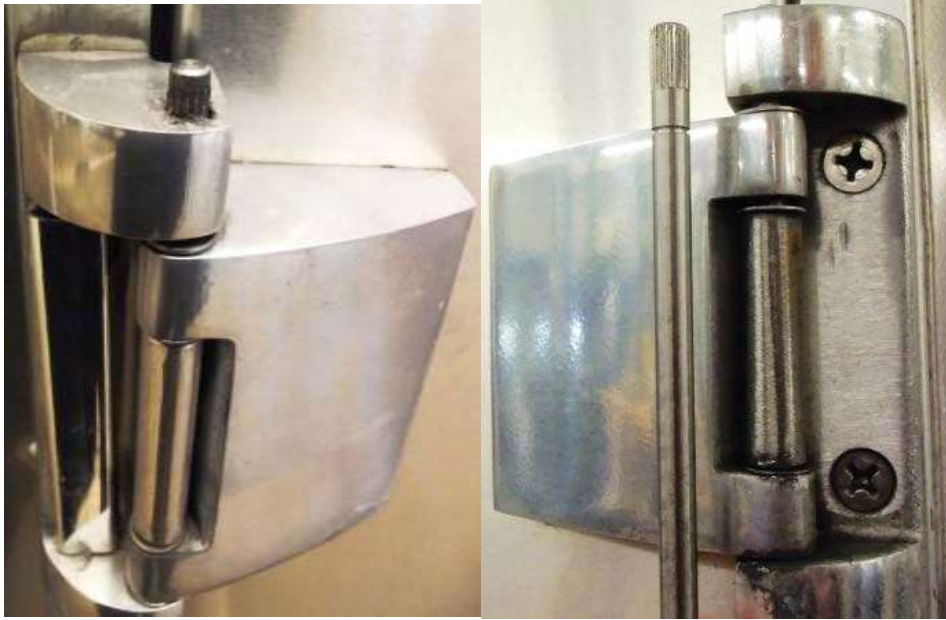
Here is an answer to the question on “how do I keep the main door hinge pin from working out of the castings?” First thought would be to make sure you lubricate the hinge pin at the joints between the inner and outer hinge joints. If the door is not lubricated on a regular basis (once a month, when possible, with something such as graphite or silicone spray) the pin can, over time, begin to collect dirt and or oxidize. The door hinges will then start to bind and can cause the pin to move in the casting versus pivoting on the hinge pin (eventually working its way up). The symptoms will be a door that opens hard or squeaks when opening and the pin can work its way up out of the castings.

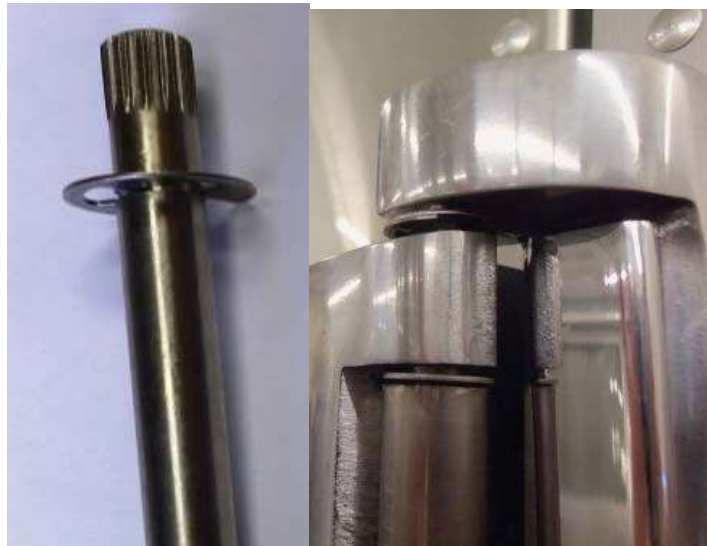
Airstream has added a groove to the hinge pin that accepts a “C” clip that is installed at the top hinge joint once the pin has been inserted into the castings.

The part # for the main door hinge pin is 381552-100 & the C clip is 381552-101. This hinge pin will also work on Classic motorhome door hinges as well.
