Rub rail & Belt line inserts

The following is based on some experiences with a gentleman's 2006 Airstream Classic.

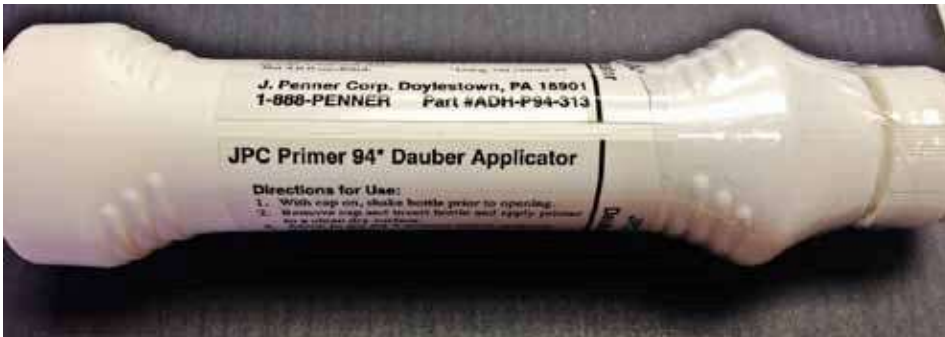
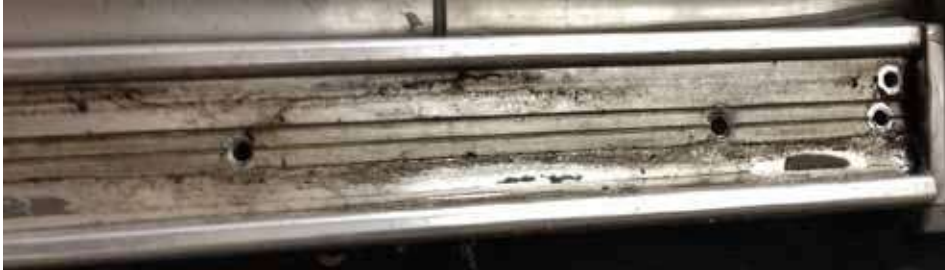
The chrome insert molding in the beltline and lower rub rail will eventually sunburn and turn the surface white or cause the clear covering to wrinkle.

If, after several attempts to restore the chrome finish have proved unsuccessful, it will become necessary to replace the insert.

The insert has a high strength adhesive commonly used to secure trim in the automotive industry. Removal of the old insert is relatively simple. Once you pry an end loose, it can be simply be pulled off the coach.

Cleaning the old adhesive should be done using a rag and denatured alcohol or equivalent. Be sure that whatever solvent you use does not leave a residue (like Goo Gone) as this will not allow the insert adhesive to fully adhere and it will eventually fail. (Lesson learned). Alcohol works well and leaves no oily residue. There also are some adhesive primers that can be purchased that will aid in getting the inserts to adhere to the metal. Airstream PN: 365249

Using the old insert, determine the approximate length with a little extra to make sure you have enough. Metal shears or other straight edge cutter are best used to cut the insert. Simply peel the protective strip off and press the insert into the molding. Several of the insert runs are quite long so a helping hand will be useful.
