Caring for your propane bottle

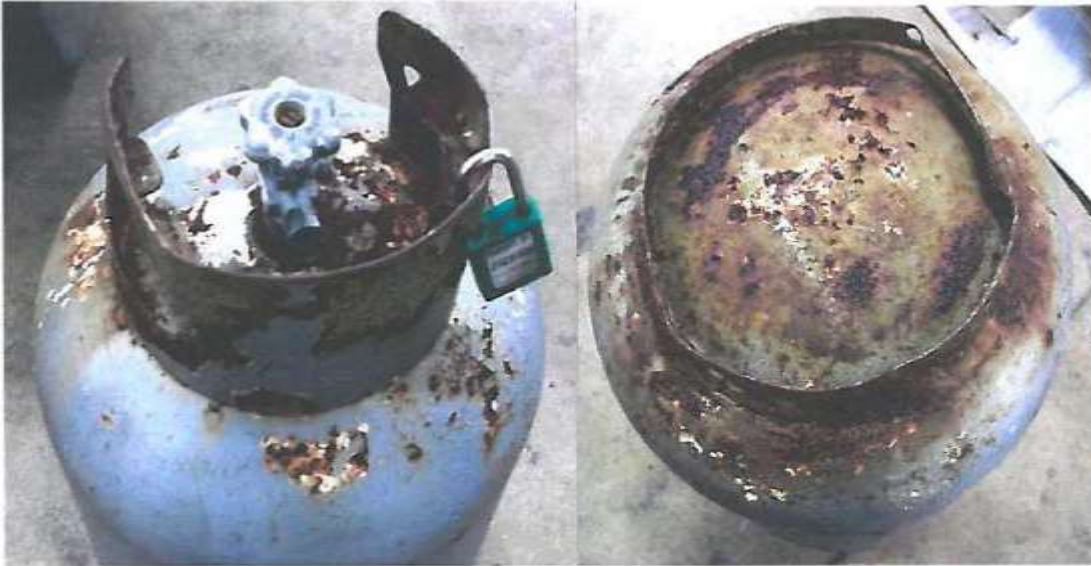
If the cylinder looks like the example above please have it properly disposed of.
