## Hot Water Odor

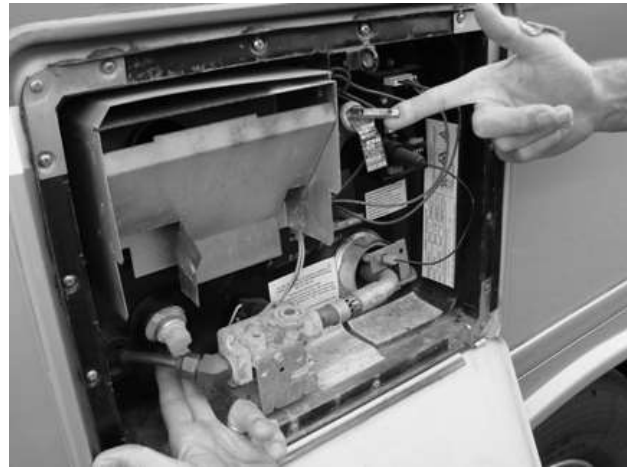
1. Remove the drain plug (left hand in photo) from the water heater tank, drain the water out, and replace the plug.
2. Remove the pressure-temperature release valve (right hand in photo) at the top of the tank.

3. Fill the tank through the relief valve hole with a 2 to 1 ratio of white vinegar to water. In a 6 gallon tank this would require gallons white vinegar and 2 gallons water.

4. Reinstall the pressure-temperature relief valve.
5. Cycle the water heater by heating and cooling in the normal manner. When the propane burner shuts off (water is heated), turn the system off and allow it to cool to ambient temperature each time. This should be done 4 to 5 times.

6. Remove the drain plug when the water has cooled and drain the tank.
7. Hook up the hose and turn on city water pressure to flush the water heater of any sediment through the drain opening. o this for approximately five minutes.

8. Replace the drain plug and refill the tank with sulfur-free fresh water.
